**INTERNATIONAL SYMPOSIUM ON  
DAMS IN A GLOBAL ENVIRONMENTAL CHALLENGES**  
Bali, Indonesia, June 1<sup>ST</sup> – 6<sup>TH</sup>, 2014

**COULD THE FAILURE OF TETON DAM HAVE BEEN PREVENTED  
WITH AN EFFICIENT MONITORING PLAN?**

**J.F.A SILVEIRA**

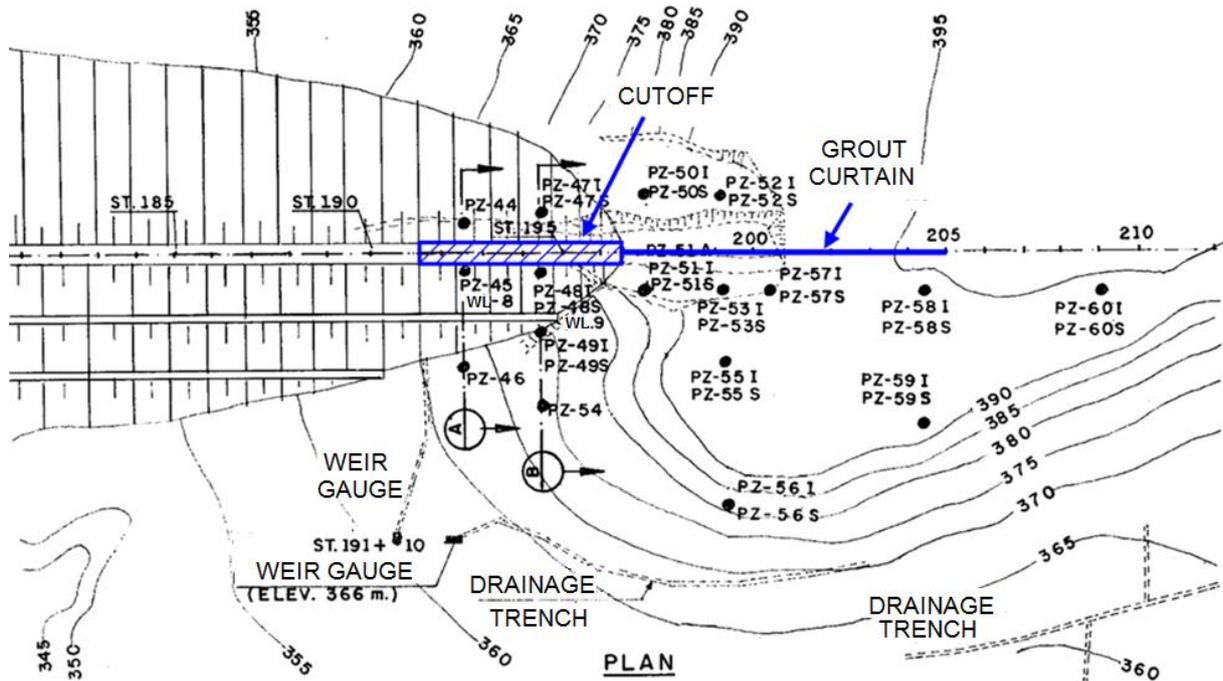
**Figure 1** - Layout of the instrumentation at the left abutment in Água Vermelha earthfill dam.

A highly permeable layer of agglomeratic lava ( $10^{-1}$  cm/s) was identified in the foundation of the left abutment of Água Vermelha Dam, which required detailed studies in the design phase. Due to the Teton accident in 1976, a concrete wall was constructed upstream of the cut-off trench, in the foundation of the left abutment, to ensure a good seal. A grout curtain was constructed with three lines of grout holes which penetrated the abutment as shown in Fig.1.

The instrumentation plan for the region of the left abutment of Água Vermelha Dam consisted of two cross-sections in the cut-off region with upstream and downstream piezometers and two additional abutment sections to control the water pressures in the region of the abutment. A flow meter was installed in the output of the drain of station 191+10 m, and water samples were collected from the reservoir and this drain, during the filling of the reservoir, to measure the concentration of solids in suspension and dissolution [3].

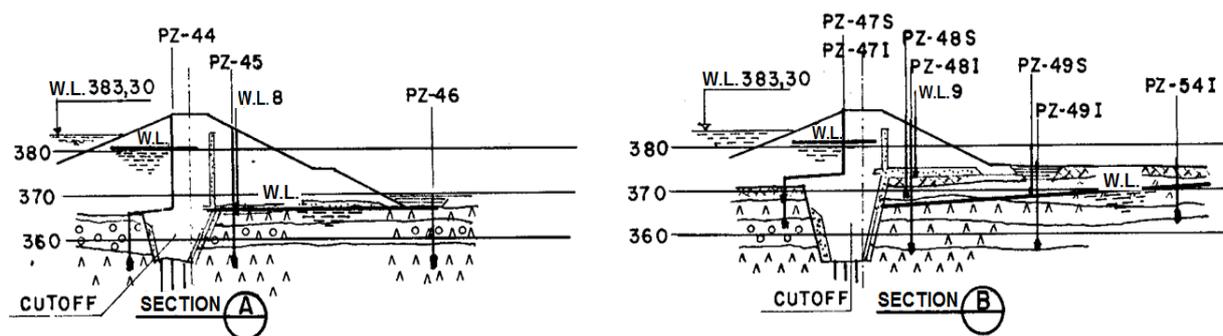
**Figure 2** - Layout of instrumentation in the cutoff trench.

The positive results provided by the instrumentation in the region of the left abutment of Água Vermelha Dam permitted the three-dimensional analysis model of percolation conditions through the abutment. The results shown in reference [4] confirm the excellent performance of the cut-off trench with the upstream concrete wall.

The piezometers installed upstream and downstream of the cut-off at their average elevations permitted the calculation of the sealing efficiency of this device after filling. In March 1979, this efficiency achieved an 82%, as a probable contribution of the concrete wall upstream of the agglomeratic lava layer.

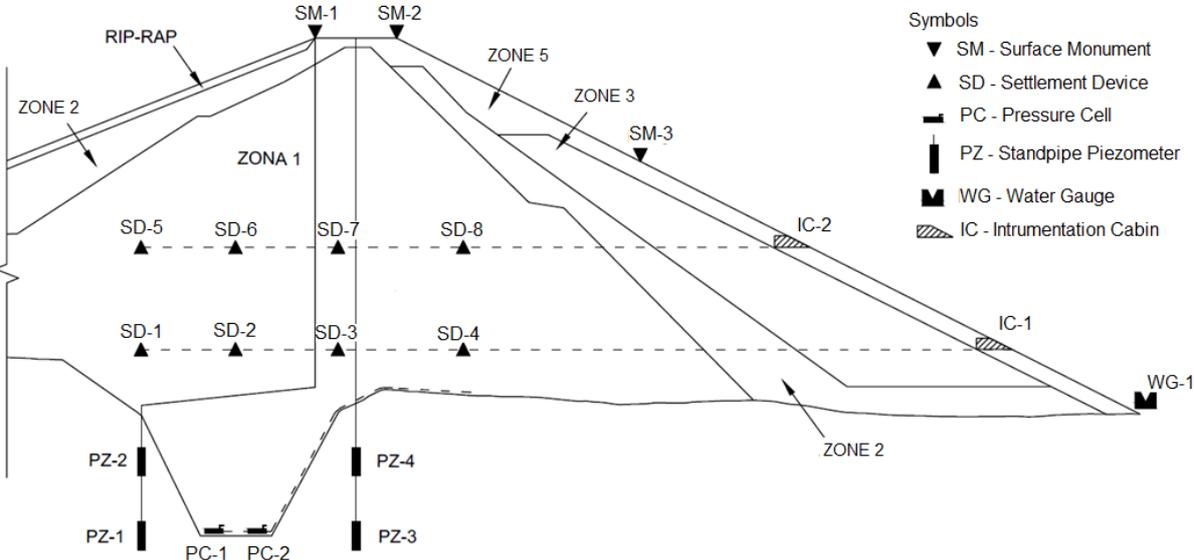
**Figure 3** - Instrumentation layout proposed for the right cut-off trench of Teton Dam.

The general arrangement of the instrumentation proposed for the right abutment of Teton Dam is shown in Fig. 3; instruments should be installed in a minimum of 2 cross-sections of the deep cut-off. In this instrumentation arrangement, the installation of standpipe piezometers, upstream of the cut-off, is possible as shown in Fig. 3, providing that the tubing does not rise vertically and incorporates a subhorizontal section with the proper slope to prevent air bubbles. A similar scheme was employed in the left abutment of Água Vermelha Dam with satisfactory results.

- Piezometers PZ-1 and PZ-3 are installed on the same level of the base of the cut-off. They should permit prompt detection of piping initiated on the earthfill-rock interface near the cut-off base.
- Piezometers PZ-2 and PZ-4 should be installed midway along the cut-off. They would permit the detection of piping through the earthfill of the cut-off caused by hydraulic fracturing on the interior of the cut-off, which is attributed to the soil arching process.
- The settlement cells CR-1 to CR-8 should be installed inside of the earthfill above the cut-off at two distinct elevations. They help to evaluate the effects of arching caused by the cut-off and enable better calibration of the mathematical analysis models.
- The surface marks function as supports in the evaluation of the settling of the dam and its foundation.

Similar to this example, the reduction in water pressures in the PZ-1 or PZ-3 piezometers for Teton Dam (Fig. 3), associated with the increase of the water pressures in PZ-2 or PZ-4, would have promptly indicated the beginning of a piping process, even during the filling phase of the reservoir. Due to the high susceptibility of the aeolian silts to the piping, the internal erosion process would have developed rapidly and been reflected in the rapid response of the foundation piezometers.

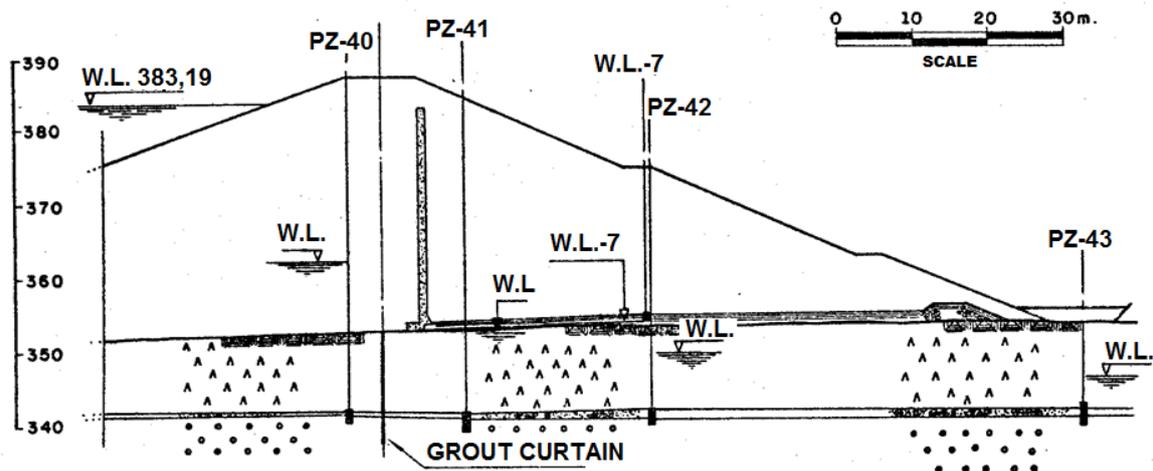
**Figure 4** - Instrumentation layout at station 181+10 and piezometer water levels in Out/1979.

At Agua Vermelha dam piezometers had been installed also at a very pervious layer between two basaltic lava flows, as shown in Fig. 4, they permitted the detection of the loss of efficiency of the cement grout curtain immediately after filling of the reservoir. For an unexplained reason, piezometer PZ-40, which is located upstream of this curtain, began to show an accentuated decrease in water pressures after March 1979 (Fig. 5), immediately after the reservoir achieved its maximum height. Simultaneously, PZ-41, which is located downstream, began to indicate a distinct increase in water pressures and a distinct loss of efficiency of the grout curtain on the dam axis.
