Engineering Works Affected by Soft Rocks

Milton Assis Kanji

SUMMARY: Weak rock is usually defined as the intact rock presenting strength below about 25 MPa. Lately, more and more engineering projects are being built on sites dominated by soft rocks, as hard rocks might be absent in the region or the best geological sites have been already utilized. Many authors include in the category of soft rocks those rock masses that although presenting initially strengths above that upper limit, may be transformed in soft rocks under the effect of accelerated weathering, or behave as a weak rock mass with strong deformation due to high degree of jointing, high ground pressures, high temperatures, etc. Since soft rocks are usually less studied, there is a lack of knowledge about their properties and little confidence in their use. As a result, it is usual to adopt very conservative parameters for them, resulting commonly in additional economical expenses. The paper presents three cases (a dam foundation, a slope and an underground opening) to exemplify the influence of soft rocks in engineering works

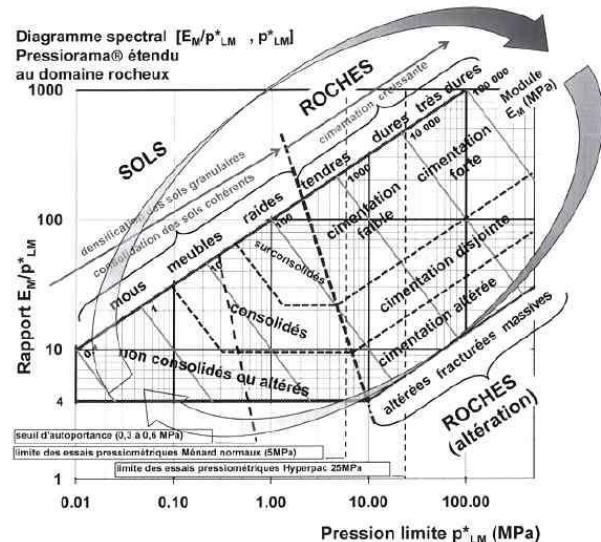
Figure 1. Pressuremeter Limit Pressure as a function of the Elastic Modulus to the Limit Pressure ratio (Baud & Gamblin, 2011).

Another criteria proposed to define the transition between soil and rock was presented by Baud & Gamblin (2011) by means of the limit pressure in pressuremeter testing, indicating values from 2 to 10 MPa depending on the elastic modulus to the limit pressure ratio, as reproduced in Figure 1.

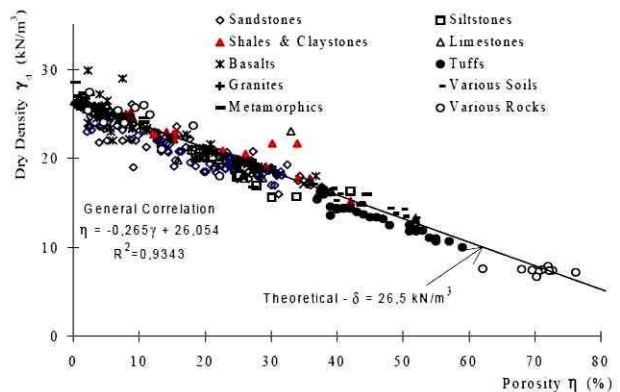
Figure 2. Plot of dry density vs porosity along the theoretical line for various rock types (Kanji & Galván, 1998)

density, it was seen that there is a gradual transition of data from hard rock to soft rock and to soil, as shown by the plot of dry density vs. porosity in Figure 2 (Kanji & Galván 1998).

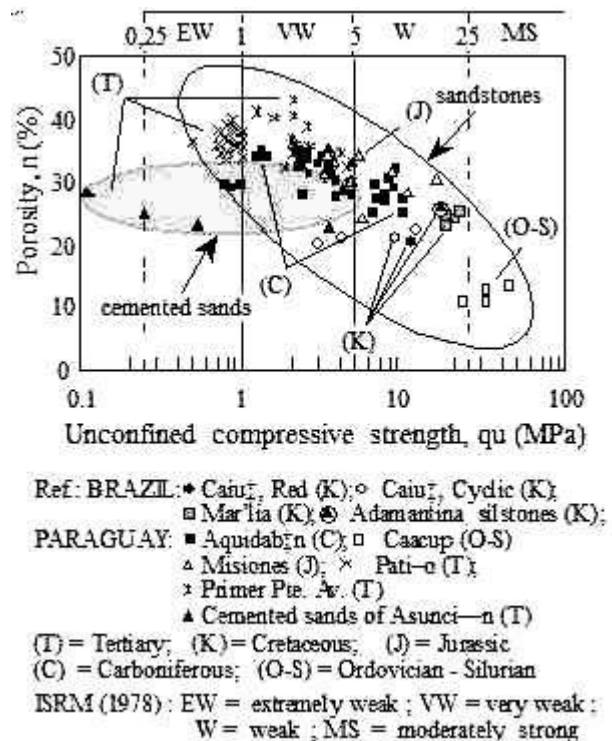
Figure 3. Graph of UCS vs Porosity for sedimentary rocks from Paraná Basin indicating their geologic age (Bosio & Kanji, 1998).

Sedimentary rocks are affected by cementation and burial pressure along the time, and most usually older rocks are more resistant than younger ones, as shown by Bosio & Kanji (1998) in Figure 3 for sedimentary rocks from the Paraná Basin (Southern part of Brazil, East of Paraguay, Uruguay and North of Argentina), with rocks from Silurian-Ordovician age presenting higher strength than the ones from Jurassic, for example. It can be seen also that the porosity decreased with age, increasing UCS.

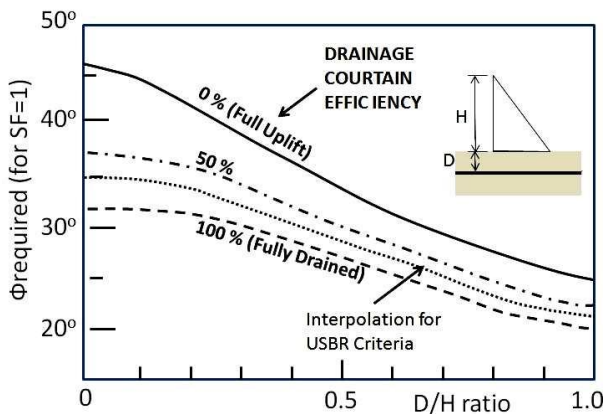
Figure 4. Necessary friction angles of a horizontal weak zone or plane at various depths within the foundation, for different drainage conditions

In concrete gravity dams the most adverse condition is when horizontal or near horizontal are present in the foundation, impairing the safety with respect to sliding. The shallower the feature (weak layer or plane) the more important it is. This fact can be illustrated by the graph of Figure 4, relating the required friction angle for Safety Factor of 1, according to the foundation drainage condition (with data obtained from Cruz et al., 1978).

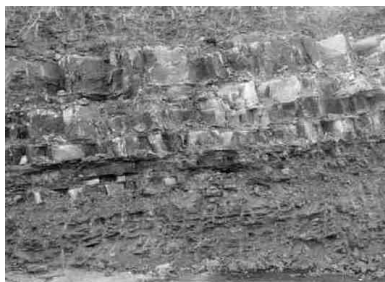
Figure 5. Siltstone intercalations in sandstone, at the Castrovido dam foundation in Spain (Alonso, 2011)

A typical example of weak layer affecting the foundation stability is that of the Castrovido Dam in Spain, mentioned by Alonso (2011), with siltstone intercalation in sandstones, as depicted in Figure 5, which obliged to changes in design due to the low strength of the siltstone.

The siltstone has IP of 10 to 12, and residual friction angles of about 15° to 18°. Coincidentally, this value coincides with the application of Kanji's (1974, 1998) expression

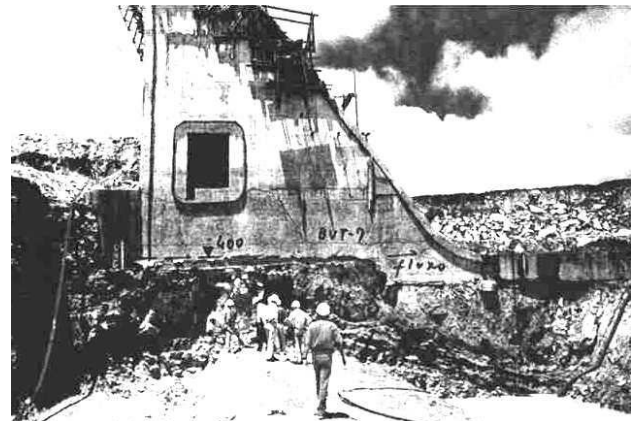
Figure 6. Soft siltstone layers in adverse position within cemented sandstone in the dam foundation.

Figure 6 show the highly adverse position of such layers with respect to the sliding stability of the dam, and Figure 7 depicts a detail of the weak bed within hard cemented sandstone.

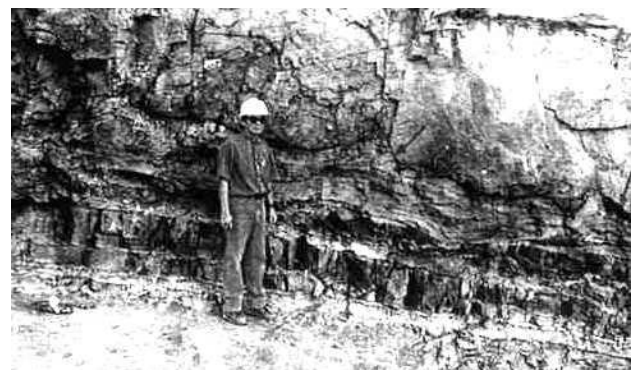
Figure 7. Detail of the siltstone intercalations in the sandstone, corresponding to a weak layer.

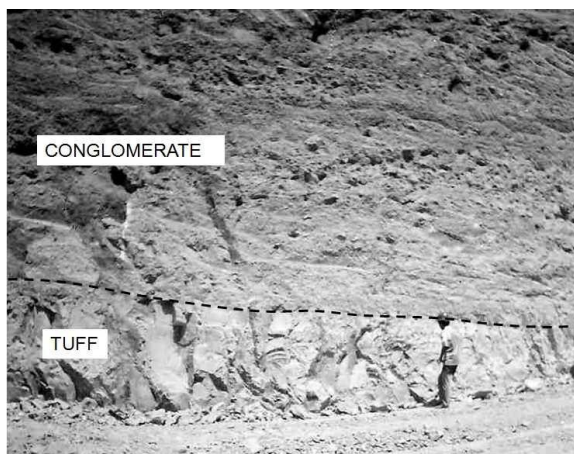
Figure 9. Picture of the failed slope showing the tuff at its foot and the conglomerate above.

The South Panamerican Highway at Palpa, Peru, had a stretch with high declivity, and it was decided to build an alternate way more adequate to the traffic, with cuts up to 42m high. Since the rock is a medium cemented conglomerate, the cut was designed with inclinations of 3V:1H with benches each 20m (instead of the 7m interval established in the national code of practice). When the excavation was about 30 m deep a weak layer of volcanic tuff dipping gently was exposed as seen in Figure 9. Tension cracks were observed at the top and the slope failed due to the tuff weakness according to the sketch of Figure 10, deduced by stability analysis.

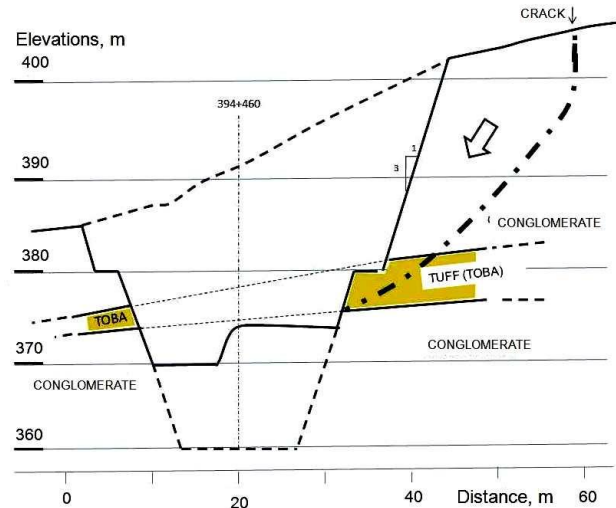
Figure 10. Sketch of the slope excavation, the tuff layer, the tension crack above and the failure surface obtained in the stability analysis.

Retro-analysis showed that the tuff has parameters equivalent to 20 kN/m^2 for cohesion and friction angle of 20° . The disaggregated tuff classifies as MH, having LL of 36% and IP of 16%. The fines percentage is of 20% to 30% with a maximum diameter of 3 to 4 cm.

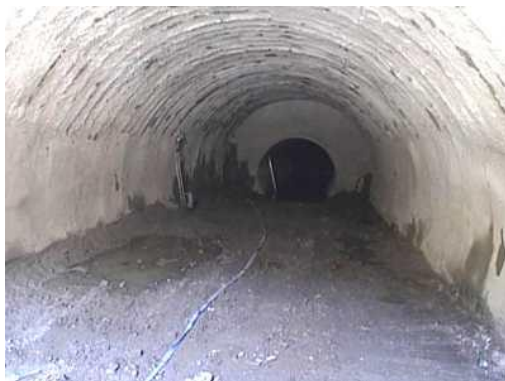
Figure 11. Aspect of the Northern part of the tunnel station the day before its collapse, with no fissures or any sign of instability problem.

Soon after the movement reactivation was noticed, the contractor called the designer, who determined the immediate reinforcement of the tunnel walls, with 3 lines of systematic 3m long rock bolts in both sides, totaling about 350 rock bolts. Figure 11 show the aspect of the North part of the tunnel, in total normality, without any sign of instability in the day of the designer inspection.

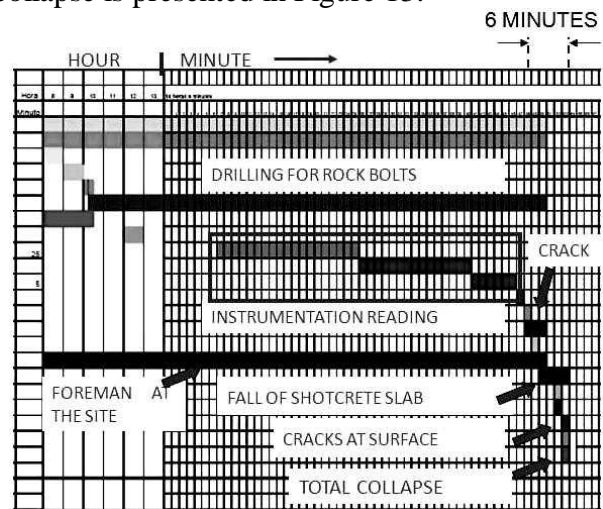
Figure 12. Chronology of the sequence of events leading to the collapse, happened in only 6 minutes (CVA, 2008, modified).

Figure 12 is a time table minute by minute showing the series of events, showing that since the first crack to the collapse, only some 6 minutes have elapsed. In the collapse unfortunately a microbus with passengers was dragged down causing 6 deaths. The view of the collapse is presented in Figure 13.

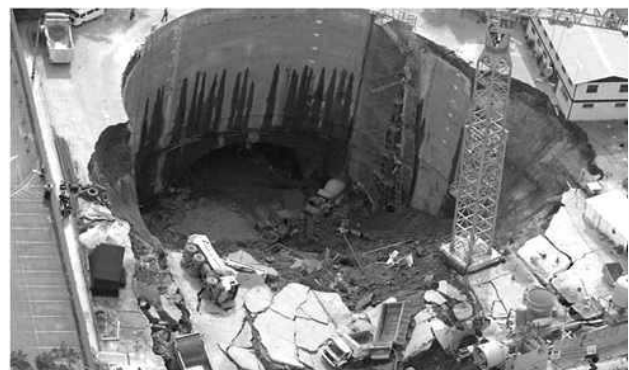
Figure 13. Air view of the collapsed tunnel and shaft.

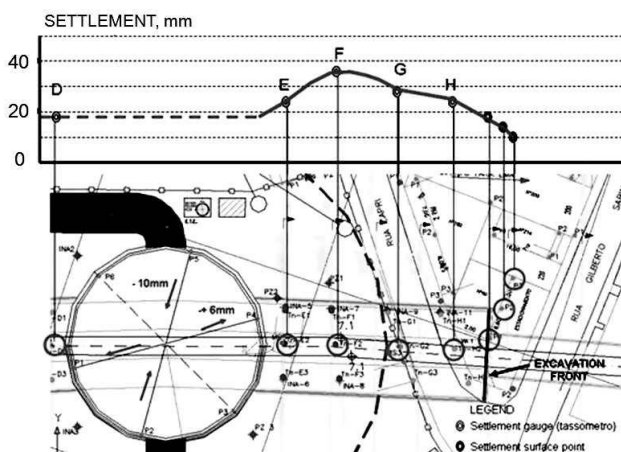
Figure 15. Surface settlements above tunnel just before the collapse, limited to about 3.5cm.

in the 18m diameter tunnel was limited to some 3cm, as can be seen in the graphs of Figure 14 (deformed slightly to fit the time scale). The settlement on surface above the tunnel was also limited to about 3,5 cm, which is striking for a tunnel with a 20m overburden, as shown in Figure 15.

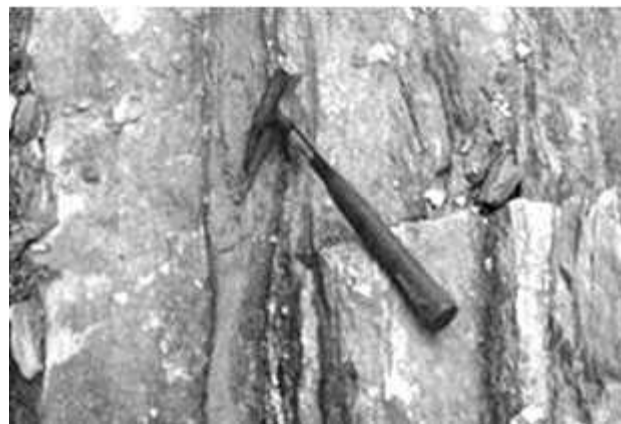
Figure 16. Vertical layer of weathered biotite schist (in the middle of the photo) within crystalline gneiss.

exposing the rock and the rock floor. The gneiss had vertical layers of weathered biotite schist very weak, in thin bands of one or two decimeters thick, as the example presented in Figure 16. One of these bands was almost parallel to the left wall and as the excavation proceeded the layer became closer and closer to the excavation wall, as shown by the geologic mapping made by the contractor (CVA, 2008) shown in Figure 17.

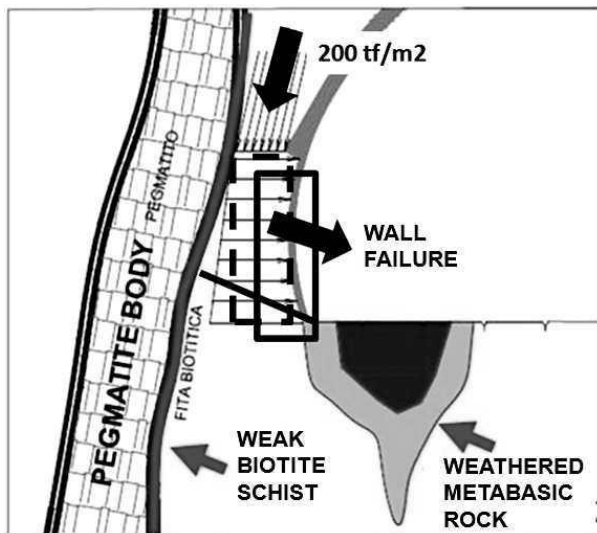
Figure 18. Interpreted mechanism of failure leading to the collapse of the station (CVA, 2008, modified)

The vertical weak layer prevented stress transfer beyond it, and the thin rock wall (of about 1m or so) received all the vertical load of the arching of the roof, overcoming the thin rock wall strength. The tunnel floor had a weathered meta basic rock which helped the failure, bringing down all the overburden, as shown in the sketch prepared by the contractor consultants in Figure 18. Additionally a somewhat weathered

transverse continuous joint at the end limit of the collapse was exposed after the event, showing that is acted as a sliding plane.
